**SUBJECT:** HARTZELL SERVICE LETTER NO: HC-SL-61-165 (DEC 7/95)

**Annex A to Pilatus Service Letter PC-12 No: 007**

Hartzell Service Letter No: HC-SL-61-165

### Propeller - Abnormal Vibration or Grease Leakage

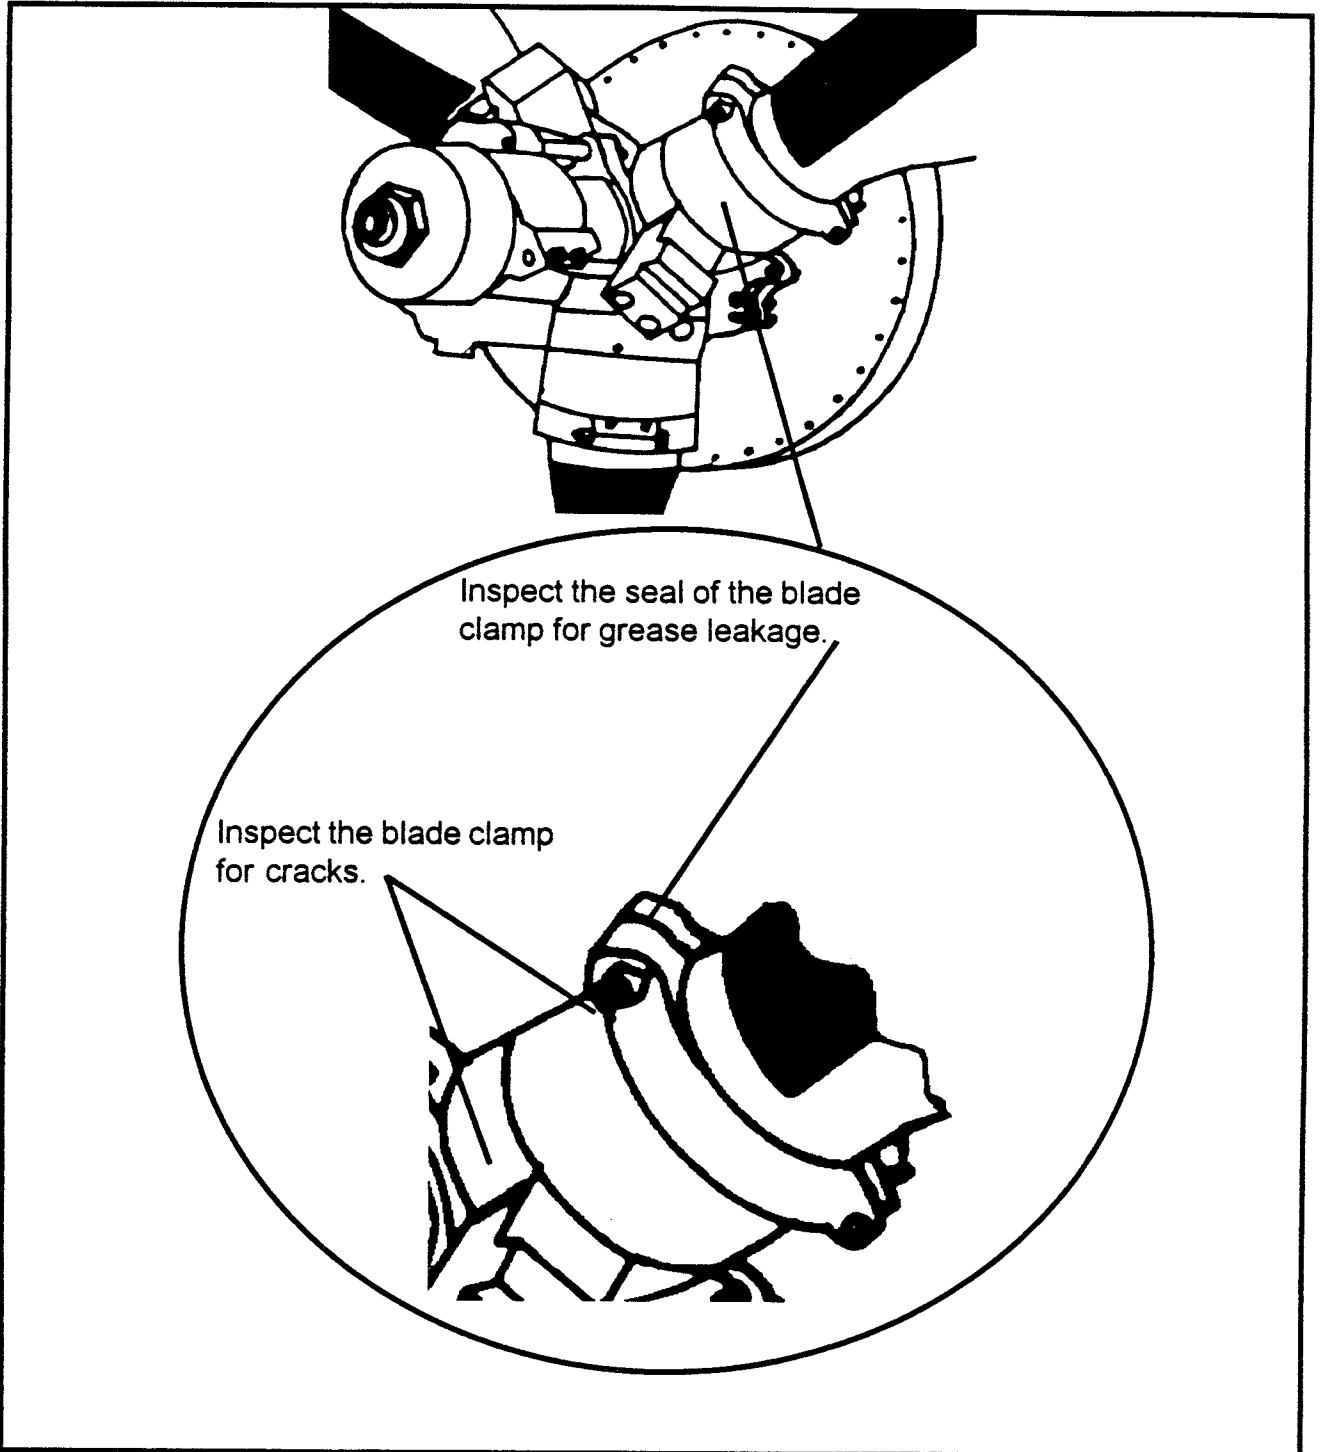
Steel Hub Clamp  
Figure 1

- (2) Perform visual inspection for cracks in the hub and blade retention areas.
  - (a) On steel hub propellers pay particular attention to the steel blade clamps, see Figure 1.
  - (b) On aluminum hub propellers pay particular attention to the blade retention areas of the hub, see Figure 2.

**NOTE:** Figures 1 & 2 show examples of past incidents where cracks have been found. The areas shown should not be the only area inspected.

- (3) Perform visual inspection of the hub and blade retention areas to locate the origin of leakage. If the origin of grease leakage is determined to be a noncritical part such as an O-ring or sealant, repairs can be accomplished during scheduled maintenance.
- (4) If suspected cracks are found, before further flight, perform additional inspections (by qualified personnel at an approved propeller repair station) to verify the condition. Such inspections typically include disassembly of the propeller with dye penetrant, eddy current, or magnetic particle inspection of parts in accordance with published procedures.
- (5) If cracks or failing components are found, parts must be replaced prior to further flight. Such incidents need to be reported to airworthiness authorities and Hartzell Propeller Inc.

- (7) If cracks or failing components are found, parts must be replaced prior to further flight. Such incidents need to be reported to airworthiness authorities and Hartzell Propeller Inc.

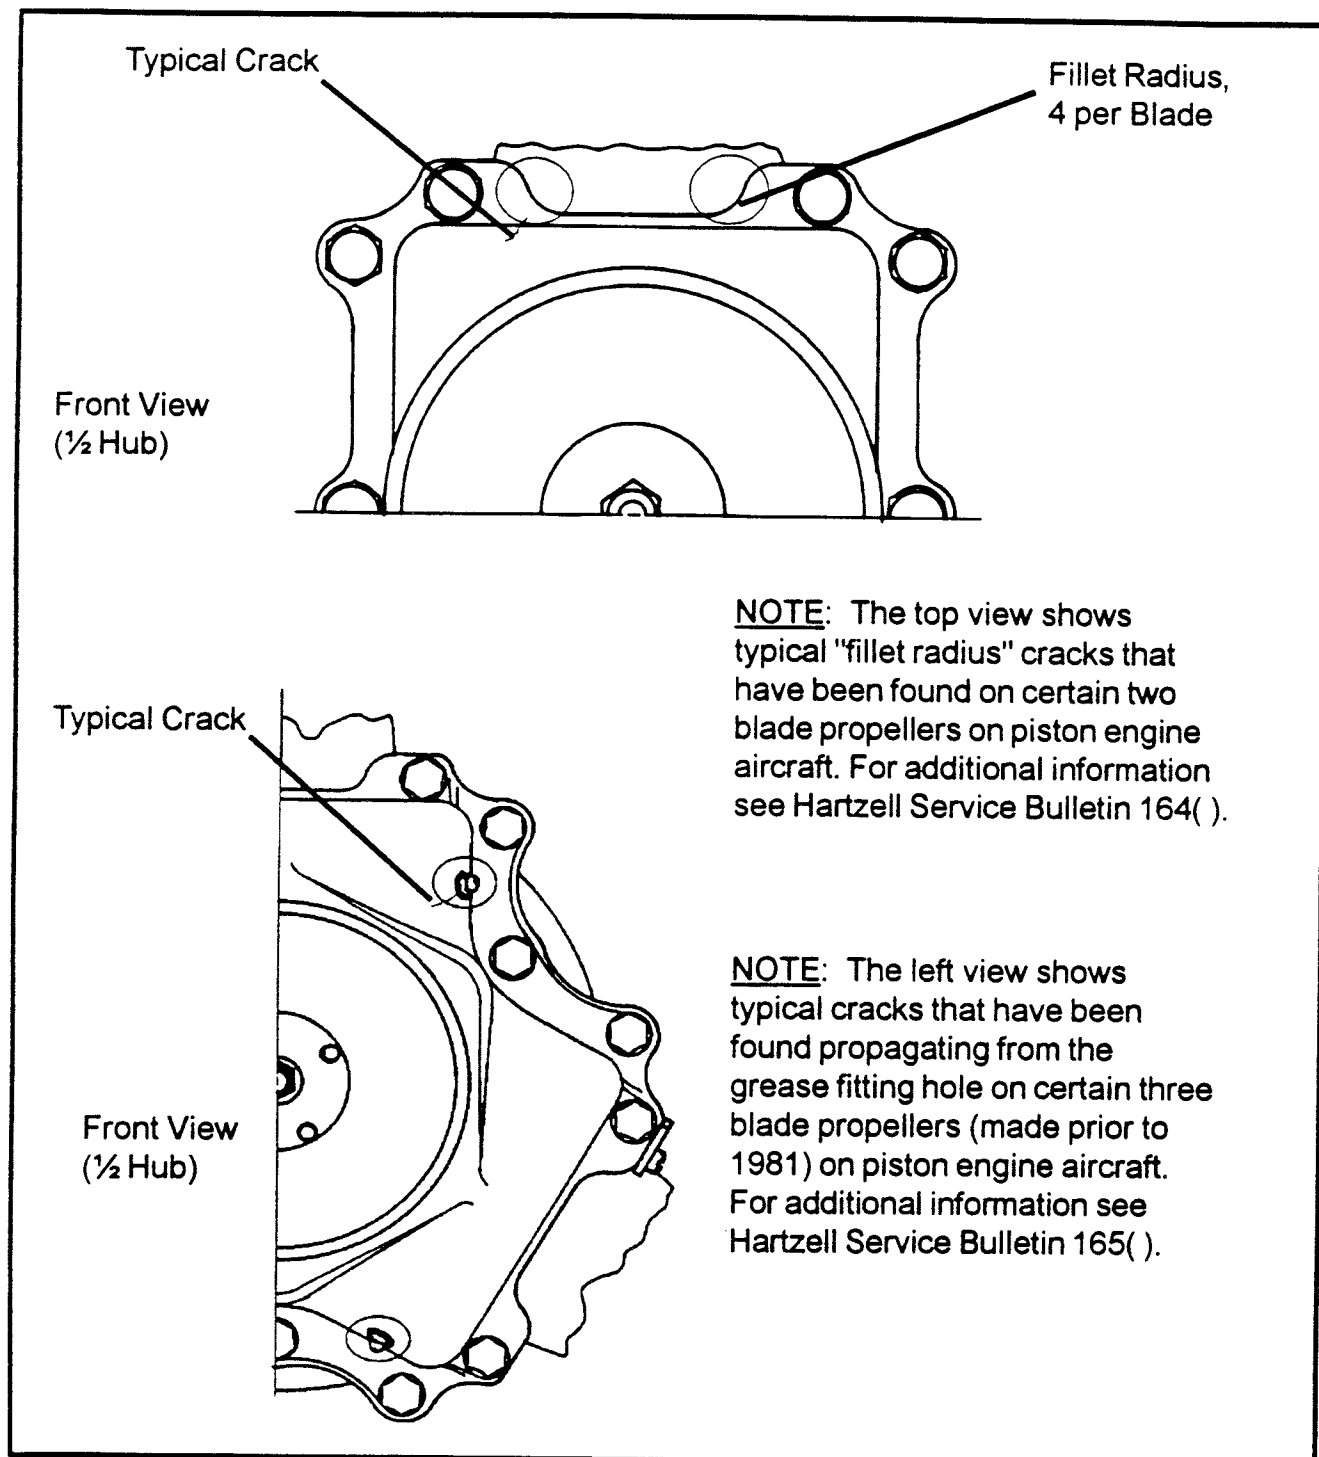
Aluminum Hubs  
Figure 2

**NOTE:** Figures 1 & 2 show examples of past incidents where cracks have been found. The areas shown should not be the only area inspected.
