SERVICE LETTER

SUBJECT: PRATT & WHITNEY CANADA SERVICE BULLETIN NO: 14251R1 (02-12-96)

TURBOPROP ENGINE - BLEED OFF VALVE (BOV) COVER, INSPECTION AND/OR

TURBOPROP ENGINE
BLEED OFF VALVE (BOV) COVER - INSPECTION/REPLACEMENT OF

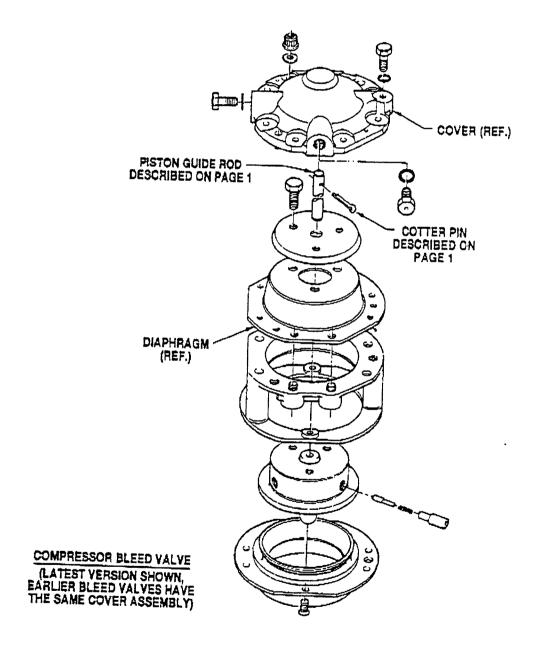
Investigation of the two bleed valves revealed a broken cotter pin, the pieces of which interfered with movement of the bleed valve piston. The illustration on page two shows the location of the cotter pin. The cause of cotter pin breakage has been identified as stress loading from the piston guide rod, which was found to be installed improperly in the two cases mentioned above. The guide rod was found to be losse, a deviation from the engineering drawing requirements. See the page two illustration for detail.

P&WC will issue the above referenced Service Bulletins (November 1996) that recommend a one time inspection of all bleed valves installed on engines within a serial number range. All spare bleed valve assemblies should also be inspected. In addition to providing instructions for the inspection, the Service Bulletins will refer to Commercial Support Program Notification No. A96036 which will provide for labour allowance, free issue of consumables and a replacement bleed valve cover if required.

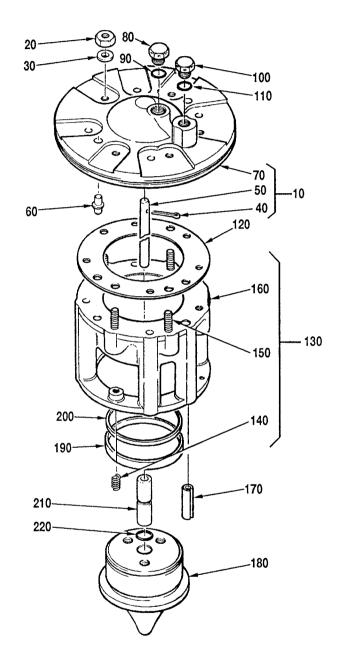
Compressor Bleed Valve Cover Inspection and Replacement Area Figure 1 (Sheet 1 of 2)

Possible movements of guide shaft pin can result in wear indications or fracture of the cotter pin.

- (b) Remove the cotter pin P/N MS9245-30 (Ref. 40).
 - (c) Inspect middle section of the cotter pin for marks, dents, grooves or any evidence of pitting, pinching or any wear (Ref. View A).

- (d) Special attention should be placed on the interface areas between the guide shaft pin and the cover bore where the cotter pin may be subjected to shear stress as defined in Figure 1.

- NOTE: Discard the cotter pin.
 - (e) Any defect found on the cotter pin is a true indication of movement of the guide shaft pin in the bore while valve is in operation.

Perform an inspection on the cotter pin and check for any movement of BOV guide shaft pin. Replace the BOV cover assembly if any wear indications are found on the cotter pin or any movement of the guide shaft pin is apparent.

- NOTE: If this condition is found, a new compressor bleed valve cover assembly must be installed (Ref. Para. 3.A.3).
