SERVICE BULLETIN

Service Bulletin No. PBA-34-001

SUBJECT: Replacement of STC SA 00322DE 2nd Pitot Static System Pitot Heat Wires and Circuit Breaker.

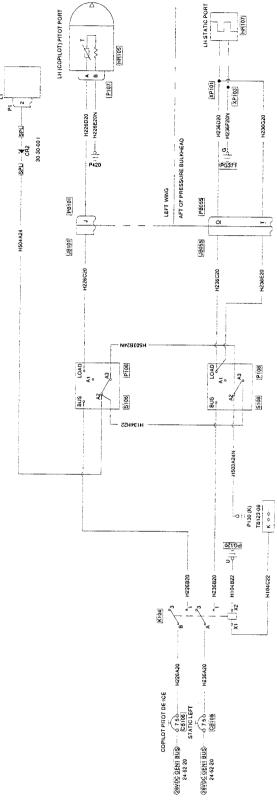
Pre-SB PBA-34-001 Figure 1

The 7.5 AMP circuit breaker and related wiring are incorrectly matched to the maximum potential, 15 AMP current draw of the pitot head.

Installation of minimum size AWG electrical cables.

- (1) Disconnect the cables from the applicable terminals (Ref. Fig. 1).
- (2) Remove the pins and connector lugs from the disconnected cables. Do not remove the cables from the cable looms.
- (3) Install a shrink cap on the cut ends of each disconnected cable.
