SERVICE LETTER

SUBJECT: FLAP MAINTENANCE ADAPTER CABLE

PILATUS Technical Memorandum (TM) - EC-12-TM-1196 (FCWU F329 Failures During Testing)

≡PILATUS≡
PC12
SERVICE LETTER

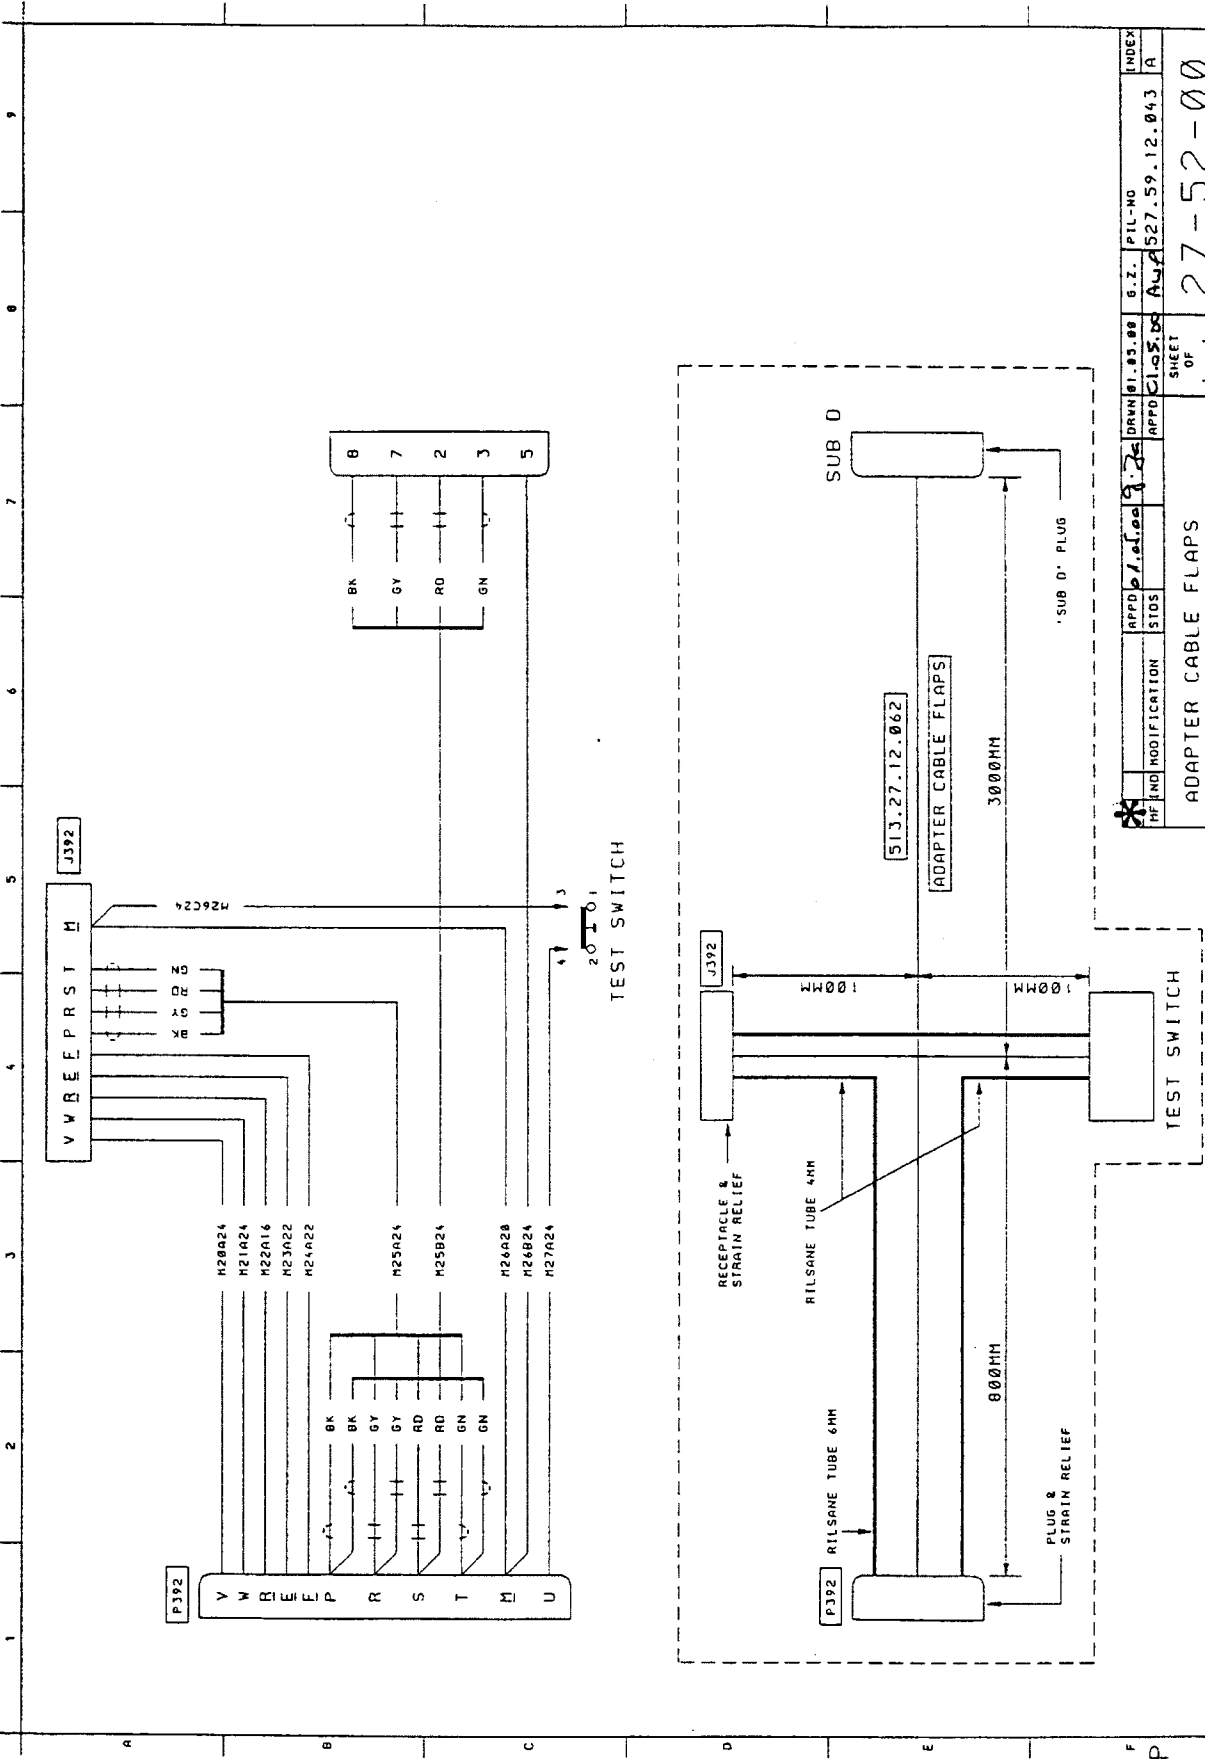
DRWN	01.03.09	G.Z.	PIL-MO	INDEX
APPD	01.03.09	APPD	01.03.09	APPD
DATE	01.03.09	DATE	01.03.09	DATE
SHEET 1 OF 1				27-52-00
ADAPTER CABLE FLAPS

<p align="center">MEMORANDUM TM</p>	<p align="center">EC-12-TM-1196</p>
PILATUS AIRCRAFT LTD STANS SWITZERLAND	<p align="center">M. Smith / ECA / Tel: 288</p>	<p align="center">24--12--00</p>
Subject: FCWU F329 FAILURES DURING TESTING		
<p><u>PROBLEM</u></p> <p>During the embodiment of SB27-008 and/or SB27-012, multiple F329 failure codes are being recorded on the Personal Computer (PC) monitor. The failure occurs when performing AMM 27-50-00 CONFIG 2 Section 3 - Flap System Set Procedure, Section 4 - Asymmetry Monitor Test or Section 5 Flap Twist Monitor Test. The failure results in the inability to Reset the flap system using the FLAP RESET SWITCH on the Maintenance Box.</p> <p><u>CAUSE</u></p> <p>The cause of this failure has been traced to a stray supply voltage generated by the PC entering the FCWU on the RS232 interface via the Maintenance Panel connector J392.</p> <p>This voltage appears on the RTS signal line and, because of coupling within the FCWU, interferes with the internal 5V power rail, preventing consistent power up resets.</p> <p>The problem occurs only on aircraft pre 9th Series as the 9th series aircraft have a different wiring configuration.</p> <p><u>SOLUTION</u></p> <p>As the FCWU / PC RS232 link is an asynchronous monitor, the RTS and CTS hardware handshake protocol is not used. Therefore these signal lines can be disconnected on the maintenance harness.</p> <p>As this is not an aircraft operational failure, it is necessary to modify the test equipment as follows:</p> <p>On APADTOR CABLE FLAPS (test cable harness) drawing number 527.59.12.043, disconnect wires M25B24 BK and M25B24 GY at connector P392 (Maintenance Panel Connector end).</p> <p>Refer to attached diagrams for details (Index A before; Index B after).</p>
