SERVICE LETTER

SUBJECT: IPECO SERVICE BULLETIN 318-25-03

Ipeco Service Bulletin 318-25-03 Issue 2 - Change to Armrest Assembly

PILATUS PC-12

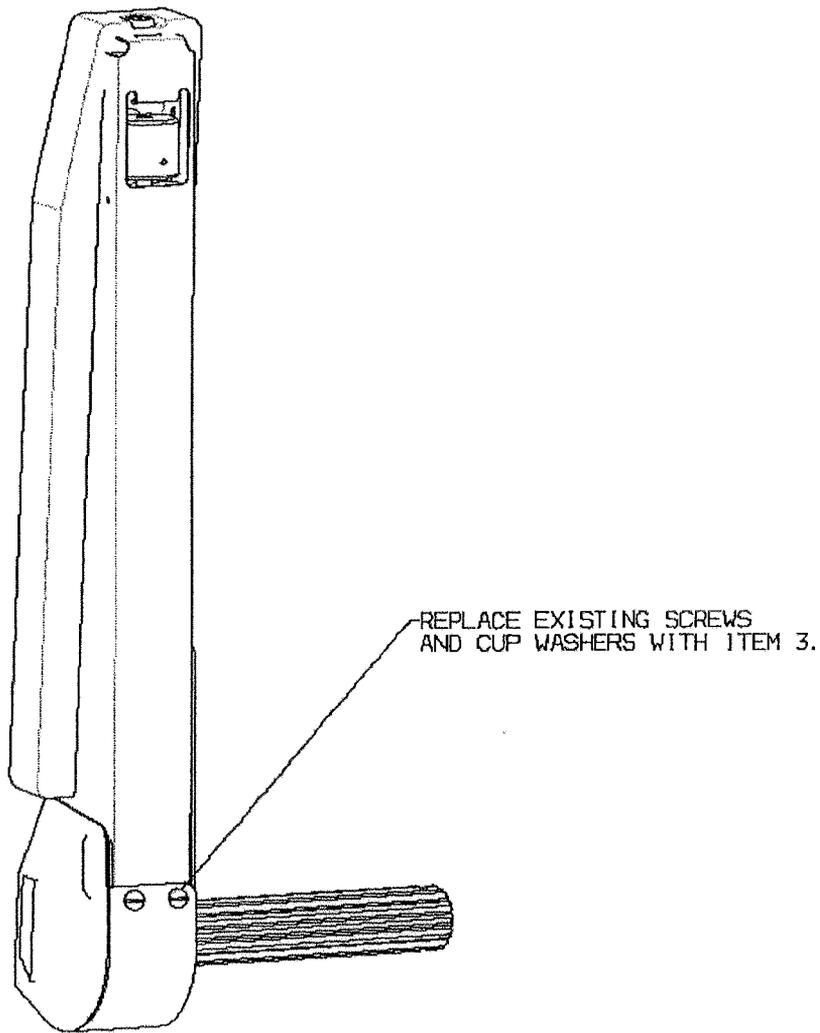
FIGURE 7
(Rest of seat not shown for clarity)

To reduce the play in the armrest and eliminate interference of screws with the Backboard.

15. Reassemble in reverse order noting to replace the two spirol pins (1-51) with new spirol pins (Item 2, table 1). See figure 5. Add four pan hd screws (Item 3, table 1) instead of the four csk hd screws (1-39) and associated cup washers (1-42). See figure 7.
