# SERVICE LETTER

**SUBJECT: INTERTECHNIQUE SERVICE INFORMATION LETTER (SIL) 69**

**OXYGEN - CREW OXYGEN MASK REGULATOR MC10 SERIES, MRA005 AND MRA022 - FULL FACE QUICK DONNING MASK REGULATOR MF10 SERIES AND MF20 SERIES - OXYGEN MASK REGULATOR / WITH DETACHABLE GOGGLES MLC20 / MLD20 SERIES - VERIFICATION OF THE SUPPLY HOSE ASSEMBLY.**

**TITLE: OXYGEN – CREW OXYGEN MASK REGULATOR MC10 Series, MRA005 and MRA022 - FULL FACE QUICK DONNING MASK REGULATOR MF10 Series and MF20 Series - OXYGEN MASK REGULATOR / WITH DETACHABLE GOGGLES MLC20 / MLD20 Series – VERIFICATION OF THE SUPPLY HOSE ASSEMBLY**

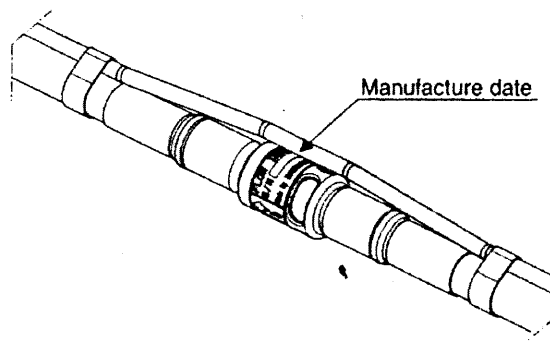
FIGURE 1

The purpose of this Service Information Letter is to inform the operators that a few number of Flight Crew Masks were found with visible cracks in the transparent plastic material of the window in the in-line flow indicator.

- (1) The cause of these cracks is a permanent stress applied in the window material. The origin of this stress is a dimensional non conformance of the flow indicator body.

- (a) If the Flight Crew Mask that you have, has a Supply Hose and Radio Cord Assembly equipped with an in-line flow indicator, check the manufacture date on the identification label (refer to Figure 1).
- (b) If the manufacture date is comprised between January 2002 and April 2003, verify if there is(are) visible crack(s) in the window transparent plastic material of the in-line flow indicator.
- (c) In case of crack(s), it is recommended as a preventive action to remove this Flight Crew Mask from the aircraft and to forward it to the appropriate maintenance facility for inspection and replacement of the supply hose assembly if necessary.
- (d) If there is no crack, use red indelible ink to make a red point after the manufacture date.

NOTE: This red point indicates that the verification has been done.
