**SUBJECT: P&WC SERVICE BULLETIN (SB) No. 14498**

P&WC S.B. No. 14498

TURBOPROP ENGINE  
POWER TURBINE STATOR HOUSING - INSPECTION OF

**PT6A-72-14498**  
Cover Sheet

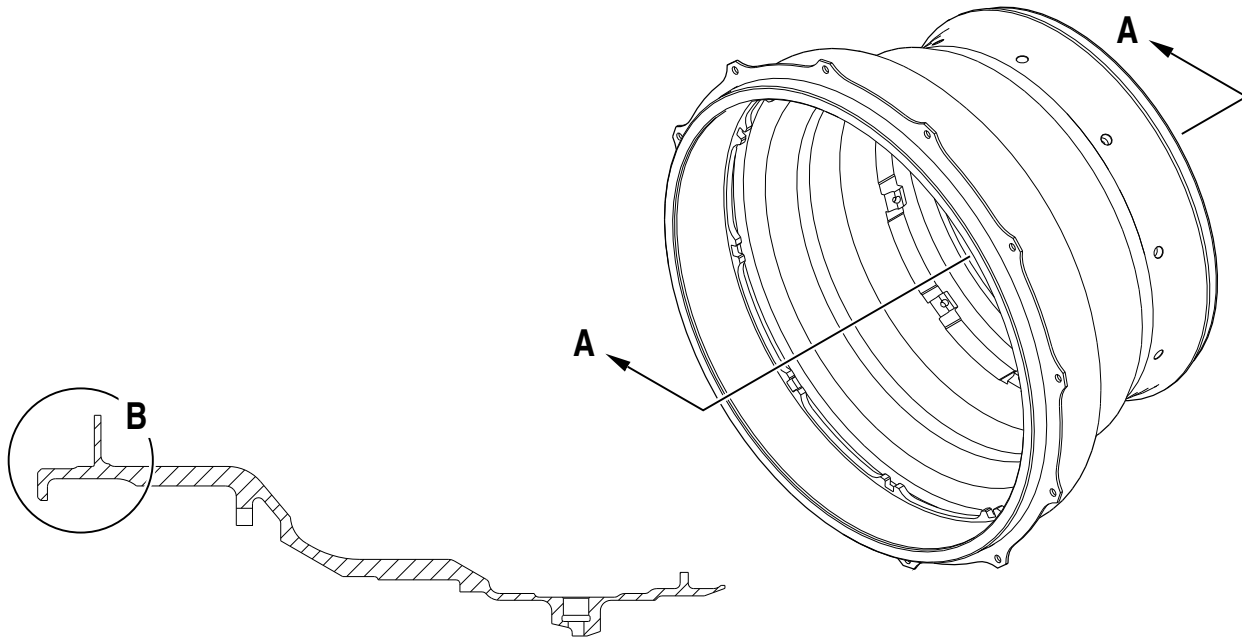
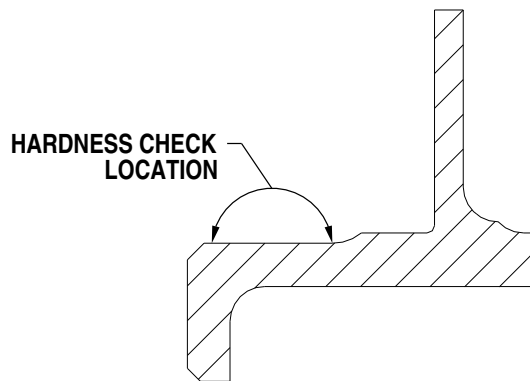
Power Turbine Hardness Check Inspection.  
Figure 1

Overhaul Manual (OHM) instructions for power turbine stator housing repair specified incorrect post-weld heat treat cycle in revisions dated Mar 24/2014. The OHM was revised Nov 18/2014 to correct the error.

OHM dated Mar 24/2014 specified heat treat SPOP 459-3 as opposed to the required SPOP 465-1 or SPOP 474-1.

- (1) For power turbine stator housing P/N 3121524-01 or 3043706-01 weld repaired per OHM dated Mar 24/2014 in another facility (not P&WC Service Centers or P&WC DOFs), measure the hardness of the part at two (2) locations equally apart on the area shown. (Ref. Fig. 1).

**HARDNESS MUST BE 36 ROCKWELL C MINIMUM.  
DO NOT MEASURE THE HARDNESS ON THE ADJACENT RADIUS.**

- (a) If the measured hardness check is equal to or more than 36 Rockwell C do as follows:

- 1 Use the vibration peening procedure, 0.003 to 0.006 in. (0.08-0.15 mm) deep, and write SB 14498 after the part number.

(b) If the measured hardness check is below 36 Rockwell C, do as follows:

- 1 Do a full heat treatment to the power turbine stator housing per SPOP 474-1.
- 2 Fluorescent penetrant inspect the power turbine stator housing per SPOP 62.
- 3 Dimensionally inspect the surface and position tolerances of the anti-rotation lugs and the sealing diameter for distortion in accordance with the applicable overhaul manual instructions (Ref. OHM 72-50-03 POWER TURBINE INTERSTAGE - REPAIR).

- 4 Use the vibration peening procedure, 0.003 to 0.006 in. (0.08-0.15 mm) deep, and write "RE 14498" to indicate heat-treat completed, after the part number.
