PILATUS AIRCRAFT LTD. STANS, SWITZERLAND

**SUBJECT: FAA SAIB NE-15-21**

**SAIB:** NE-15-21

**SUBJ:** Fuel Injector Nozzle

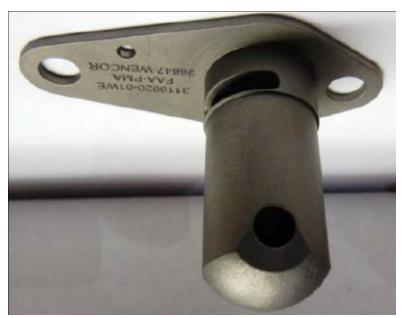
Figure 1 – Fuel Nozzle Sheath

While developing the fuel nozzle sheath, P/N 3119920-01WE, Wencor made the lower portion of the cap thicker than the OEM fuel nozzle sheath, P/N 3119920-01. A technician installing the PMA fuel nozzle sheath, P/N 3119920-01WE, on a PT-6A engine found he/she could not install the part (Figure 1), without it contacting the fuel nozzle (Figure 2) because the fuel nozzle was contacting the sheath.

A fuel nozzle that is bottomed out in the fuel nozzle sheath might affect the performance, temperature, or integrity of the engine in service. There have been no reports of operational issues to date, but since the fuel nozzle sheaths do not fit with the fuel nozzles as designed, and the effect of this condition is unknown, the FAA recommends removing all Wencor PMA fuel nozzle sheaths, P/N 3119920-01WE, from service.

- 1. The FAA recommends removing all Wencor PMA fuel nozzle sheaths, P/N 3119920-01WE, from service at the earliest maintenance opportunity not to exceed 600 flight-hours after August 1, 2015.
- 2. The FAA also recommends that all spare Wencor PMA fuel nozzle sheaths, P/N 3119920-01WE, be removed from inventory and not installed in any engine.
- 3. In addition, the FAA recommends that all removed fuel nozzle sheaths and spares be returned to Wencor.
