SUBJECT: TORQUE TRANSDUCER OIL PRESSURE PIPE INSTALLATION

Effectivity: All PC-12, PC-12/45, PC-12/47 and PC-12/47E aircraft.

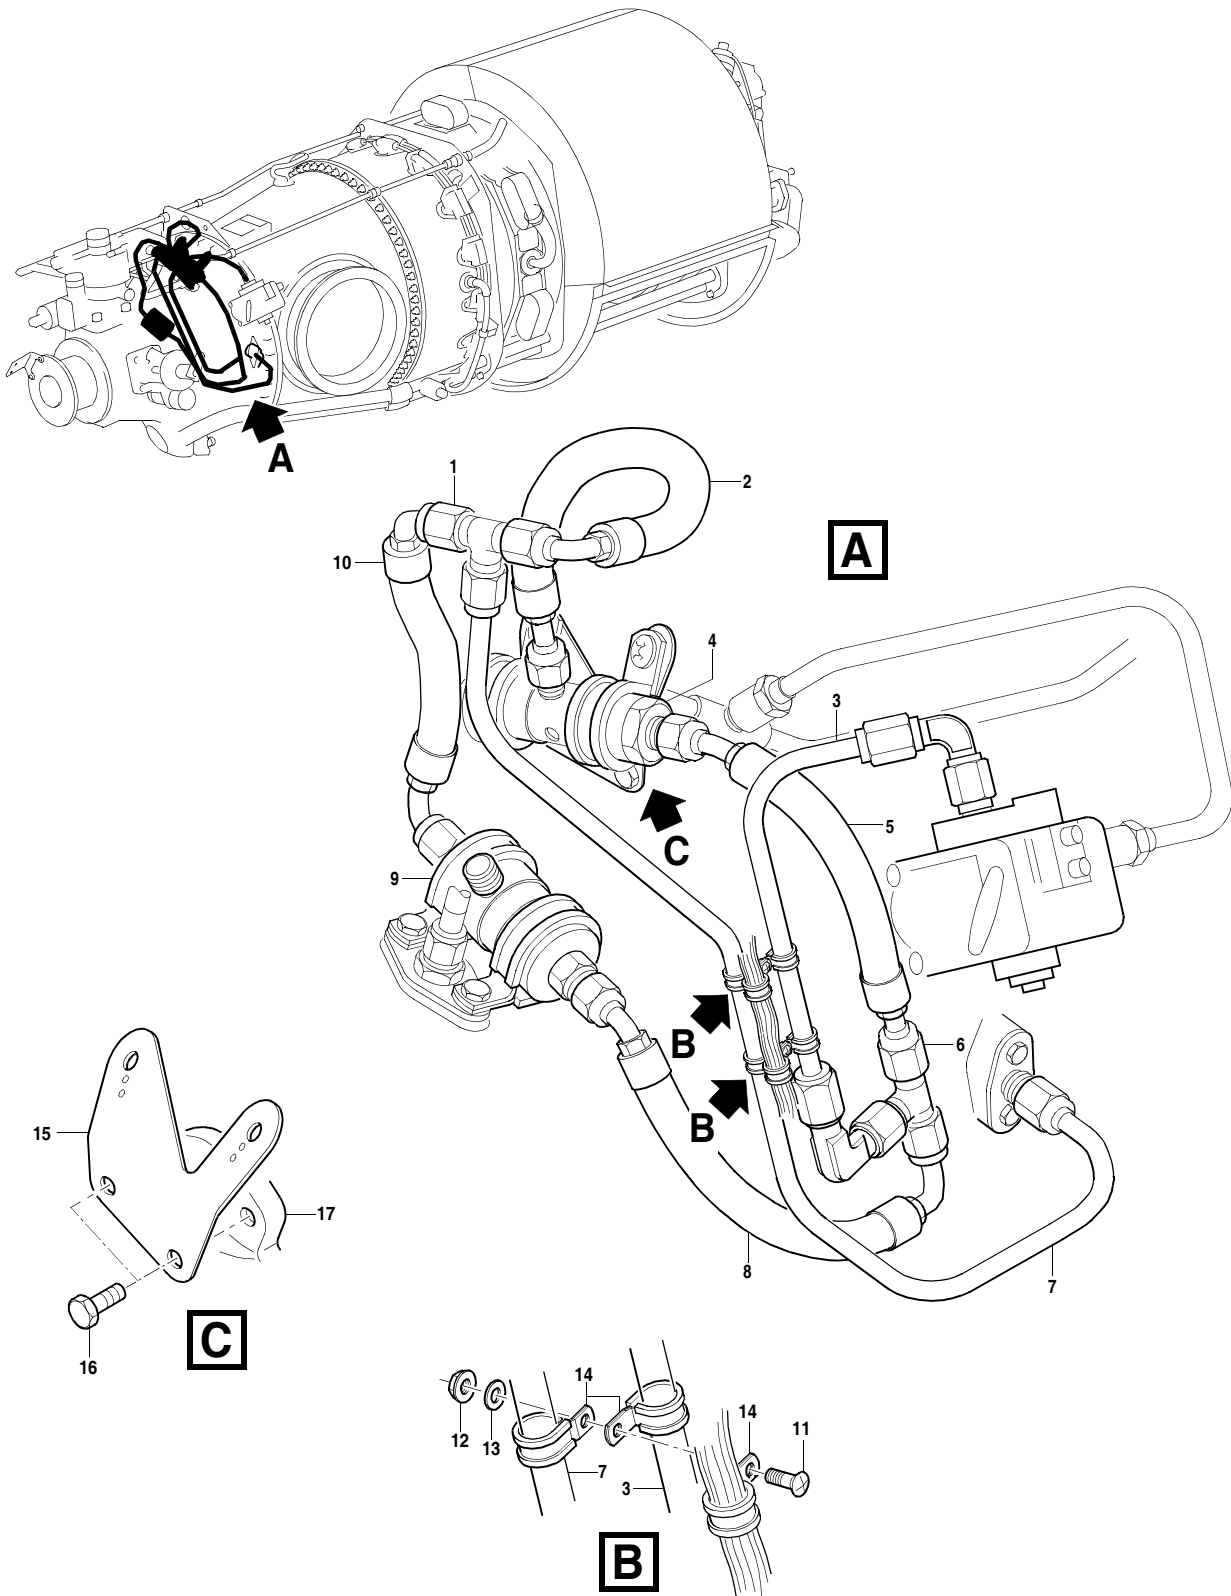
Installation of P-clamps - Figure 1

Incorrect installation, in particular wrongly installed or missing P-clamps, may result in loosening of the torque transducer oil pressure pipes with subsequent loss of engine oil. This can result in an in-flight engine shutdown.

The correct P-clamp installation is shown in Figure 1 Detail B. The P-clamps are identified as item 14. Always maintain the aircraft in accordance with the instructions given in the Aircraft Maintenance Manual.

Operators are urged to check the installation at the earliest opportunity.
