SUBJECT: ENGINE COMPRESSOR BLEED OFF VALVE - POSSIBLE TORQUE REDUCTION

Effectivity: All PC-12/47E aircraft with PT6E-67XP engine serial numbers HP0001 thru HP0138.

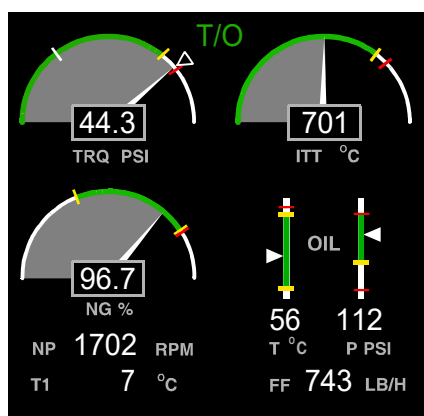
PFD ENGINE WINDOW

This Service Letter is issued to draw attention to particulate contamination of the engine compressor bleed off valve (BOV) which could lead to a possible reduction in the maximum available torque.

When monitoring the engine indication after setting take-off power (refer to the Pilot Operating Handbook Section 4.9.01), verify that the actual torque (white pointer) matches with the torque bug (white triangle). If the actual torque does not reach the torque bug, abort the take-off. BOV contamination could be suspected. The aircraft will not meet the take-off performance as given in the POH Section 5.3.2.

- P&WC Service Bulletin A75018 - BOV contamination inspection
- Pilatus Service Bulletin 71-013 mandating P&WC SB A75018
- Airworthiness Directive CF-2021-20 issued by Transport Canada.
