SUBJECT: INFORMATION ON THE MULTI-MODE DIGITAL RADIO 2

Date: Feb 25/22

Effectivity: PC-12/47E Series Aircraft MSN 1720, 2001 and Up.

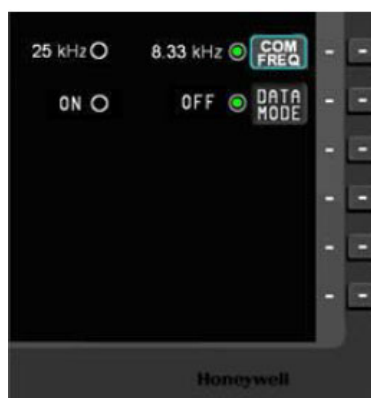
- **Problem 1:**
During power down, the data in the flash memory integrated circuits are being corrupted causing the system at power up to detect this corruption and fail the power-up built-in test. This results in a MMDR fail CAS message.
- **Problem 2:**
The RF output stage power transistor is failing due to a timing conflict between data and voice transmissions. This results in the loss of the ability to transmit on COM 2.

NOTE: Both of the above problems result in an unrecoverable radio leading to a maintenance action for removal and replacement. Problem 2 is occurring frequently and is the primary cause of the increased failure rate.

- **Work Around 1:**
 - The radio datalink transmissions can be inhibited using the "DATA MODE" radio button on the radio window detail page.

NOTE: The power up default status of this setting is ON so it is required to be done prior to every flight.
