SUBJECT: INFORMATION ON THE MULTI-MODE DIGITAL RADIO 2 (SUPERSEDES SL-225)

Effectivity: PC-12/47E Series Aircraft MSN 1720, 2001 and Up.

This Service Letter is issued to draw attention to an issue with the Multi-Mode Digital Radio 2 (KTR 2280A Honeywell P/N 069-01039-0101).

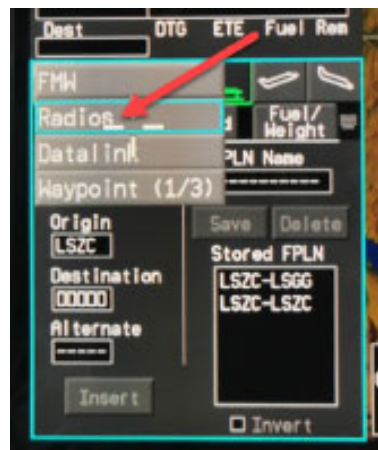
NOTE 1: For aircraft battery starts, the radio window can be accessed on the lower MFD in STBY power mode. Make sure that the focus is on the FMS window and right click the scroll wheel selecting “Radios”.

The radio datalink transmissions can be inhibited using the “DATA MODE” radio button on the radio window detail page with only STBY Bus powered.

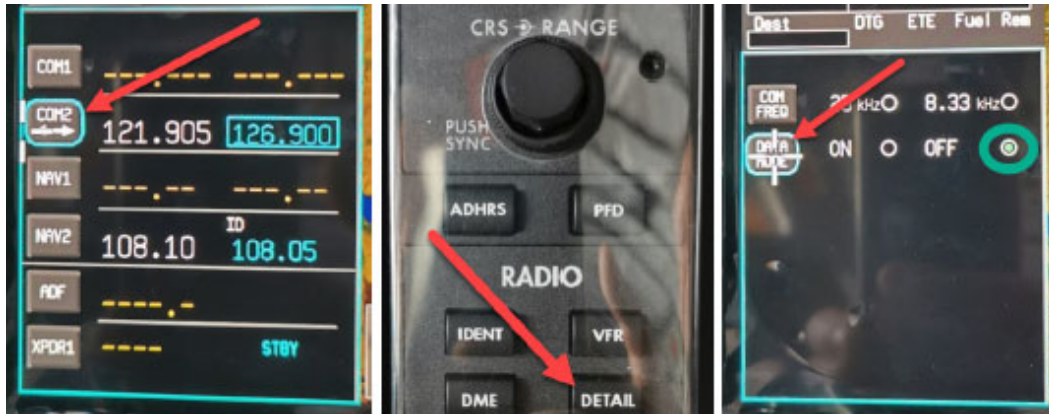
Place the cursor over COM 2 and then press the “DETAIL” button on the Pilots PFD Controller. This will then display the selection to disable the “DATA MODE”. It is important to make sure that this is completed prior to requesting engine start clearance over the radio.

NOTE 2: The power up default status of this setting is ON, so it is required to be done at every Avionics System power up.
