SUBJECT: INFORMATION ON THE MULTI-MODE DIGITAL RADIO 2 (SUPERSEDES SL-227)

Effectivity: PC-12/47E Series Aircraft MSN 1720, 2001 and Up.

This Service Letter supersedes Service Letter PC-12 SL-227.

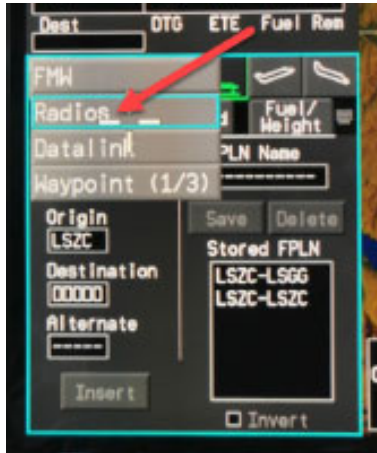
NOTE 1: For aircraft battery starts, the radio window can be accessed on the lower MFD in STBY power mode. Make sure that the focus is on the FMS window and right click the scroll wheel selecting “Radios”.

The radio datalink transmissions can be inhibited using the "DATA MODE" radio button on the radio window detail page with only STBY Bus powered.

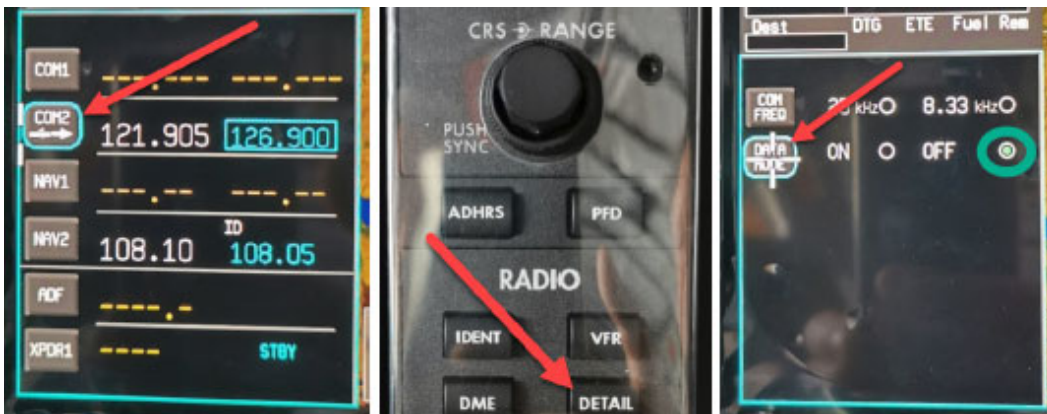
Place the cursor over COM 2 and then press the “DETAIL” button on the Pilots PFD Controller. This will then display the selection to disable the “DATA MODE”. It is important to make sure that this is completed prior to requesting engine start clearance over the radio.

NOTE 2: The power up default status of this setting is ON, so it is required to be done at every Avionics System power up.
